**DEPARTMENT OF TRANSPORTATION**

Contract #: 04-0120F4Cty: SF/ALA Rte: 80 PM: 13.2/13.9File #: 69.28**WELDING INSPECTION REPORT****Resident Engineer:**Pursell, Gary**Address:** 333 Burma Road**City:** Oakland, CA 94607**Report No:** WIR-016166**Date Inspected:** 12-Aug-2010**Project Name:** SAS Superstructure**OSM Arrival Time:** 700**Prime Contractor:** American Bridge/Fluor Enterprises, a JV**OSM Departure Time:** 1900**Contractor:** Zhenhua Port Machinery Company, Ltd (ZPMC), Changxing Island **Location:** Shanghai, China

OBG SEGMENT 9BW

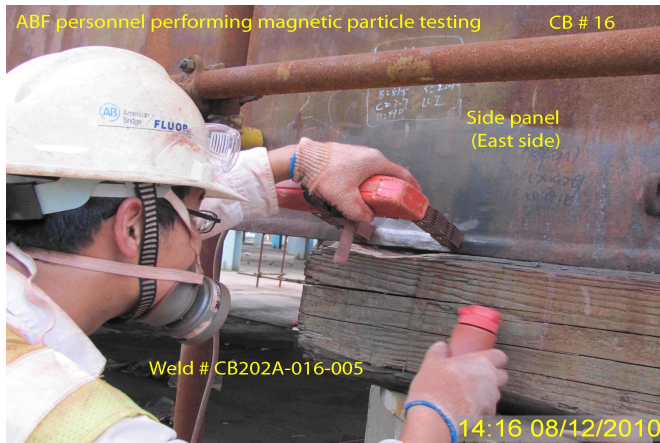
Unless otherwise noted, all work observed on this date appeared to generally comply with applicable contract documents.
